Building Information - Brunswick City (43661) - Brunswick High

Building Pictures - Brunswick City(43661) - Brunswick High(3970)

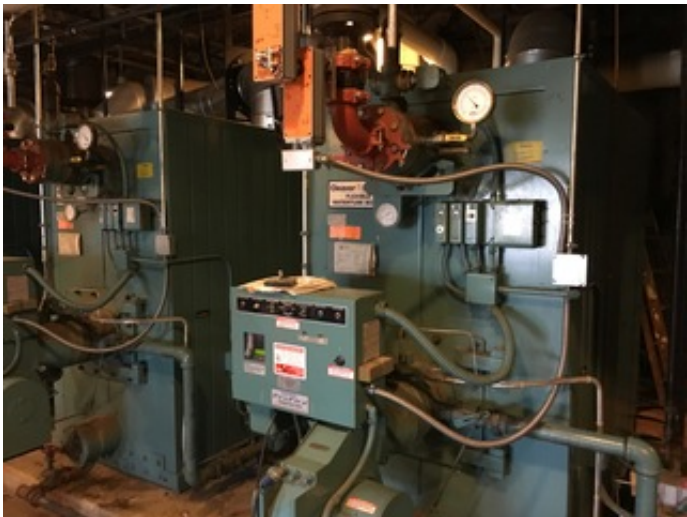
Heating water boilers

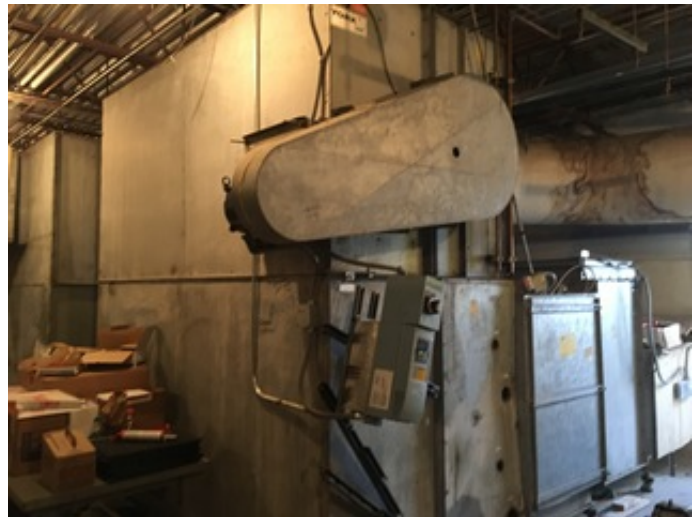
Air handling unit

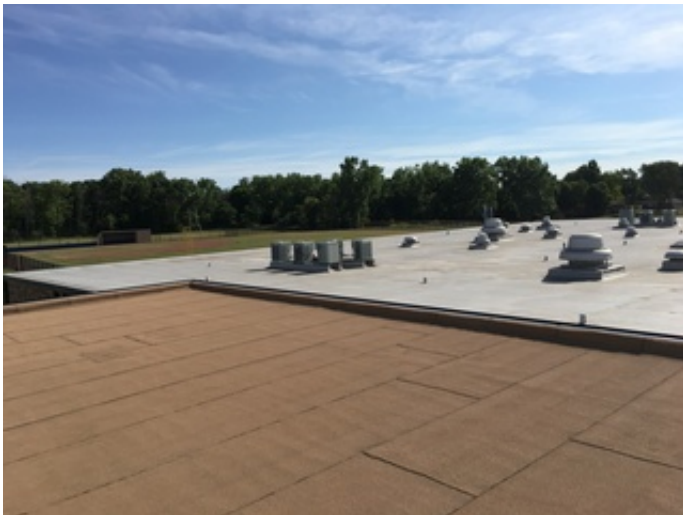
Roof mounted condensing units

Recommendations: Due to the age of the HVAC System provide an air conditioning system with new ductwork to meet with Ohio Building Code and Ohio School Design Manual requirements. Pricing included in Item A. PAC units should be replaced, due to their age (14+ years).

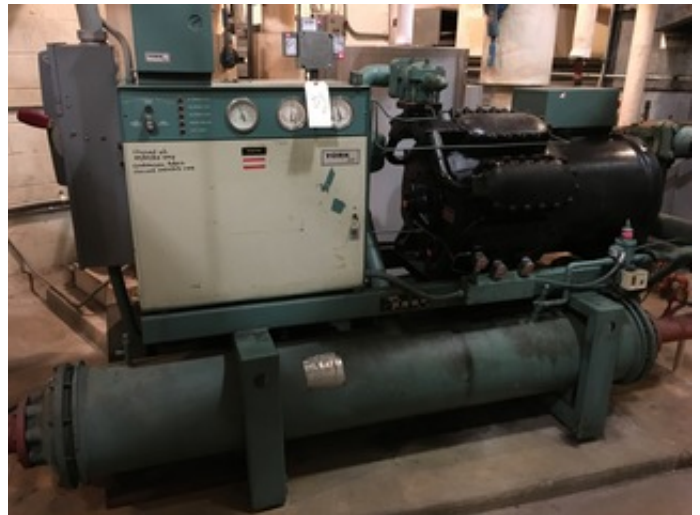
Indoor chiller

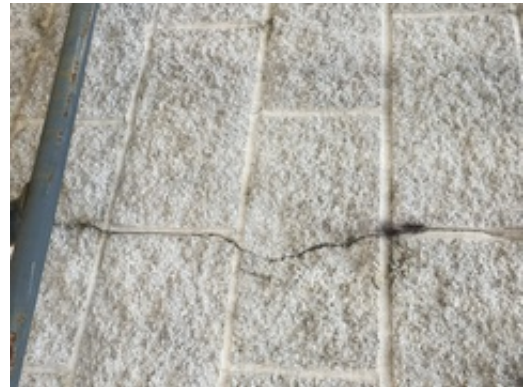
Crack at retaining wall

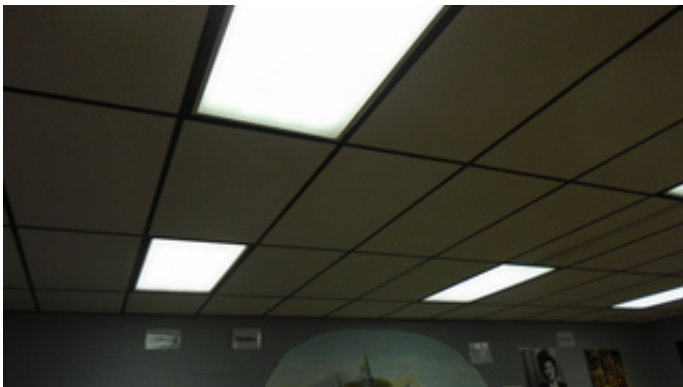
Classroom light fixtures

Recommendations: Provide complete replacement of lighting system due to replacement of the HVAC System and/or addition of fire suppressions systems, except in PAC area.

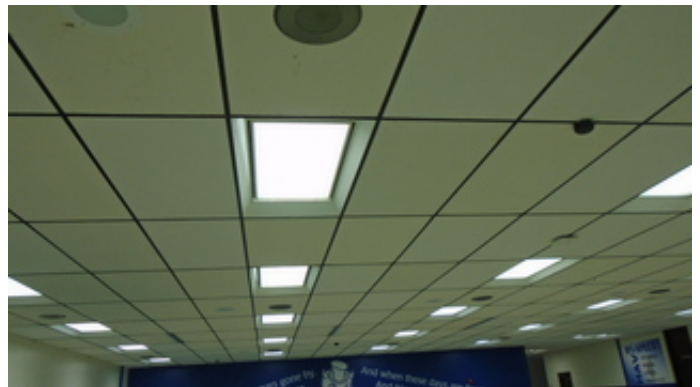
Student dining light fixtures

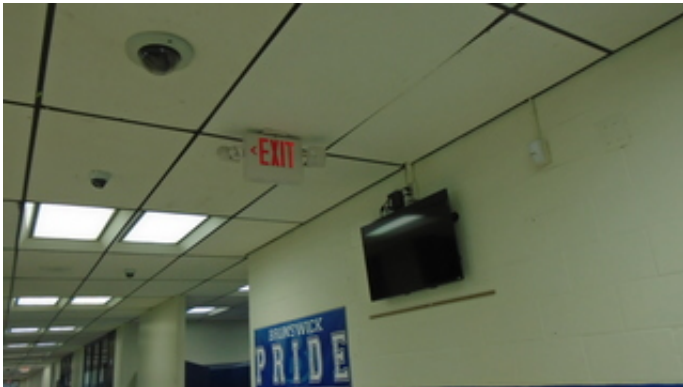
Exit/Emergency Combo

Recommendations: Provide complete replacement of emergency / egress lighting system to meet Ohio School Design Manual guidelines.

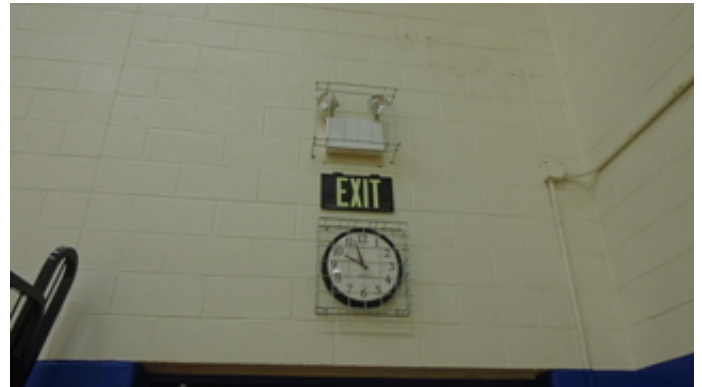
West House Gym Emergency Light and Exit Sign

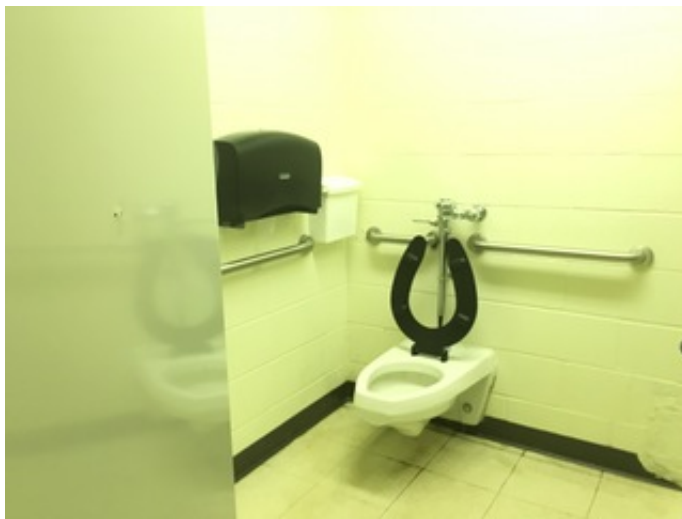
Non-conforming water closet

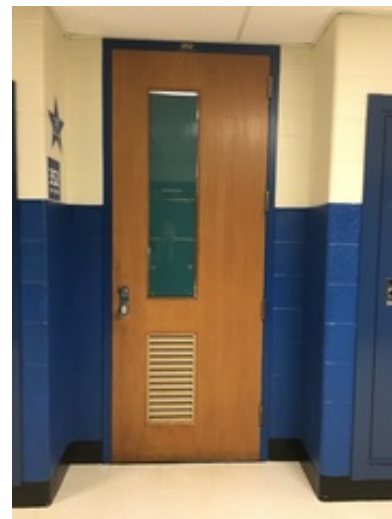
Non-conforming recessed door

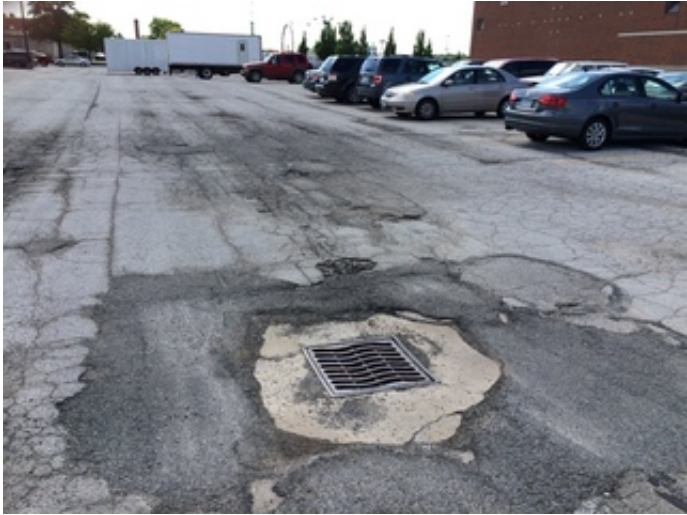
Front/west lot pavement damage

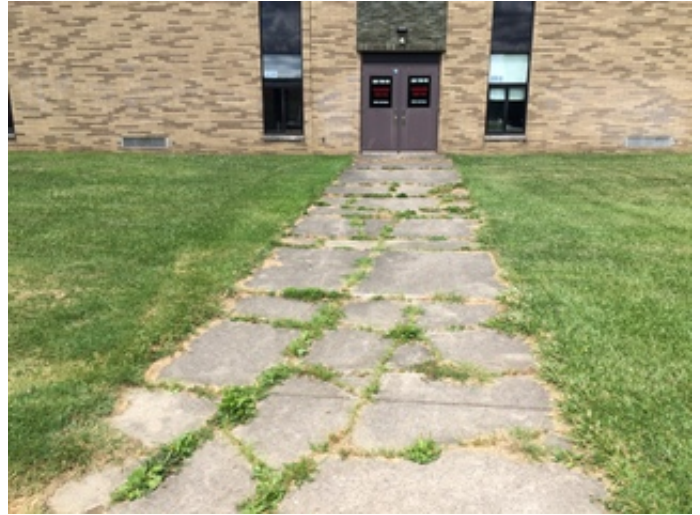
Rear east courtyard walk damage

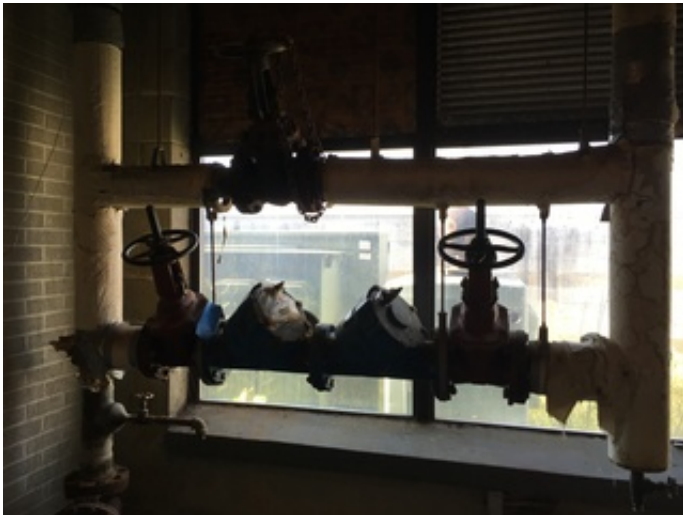
BFP branch water supply

Recommendations: Provide a new city water supply line of adequate capacity to support the existing needs of the facility, as well as a future automated fire suppression system. Funding provided in Item U. Water supply to the PAC is adequate (verify BFP).

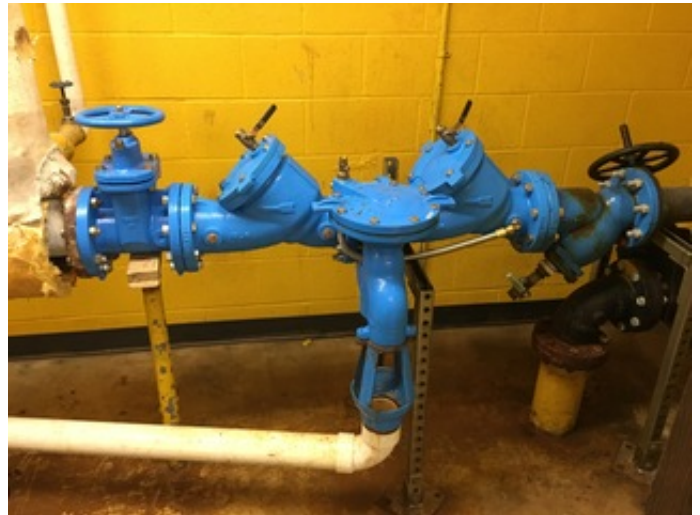
Main water BFP

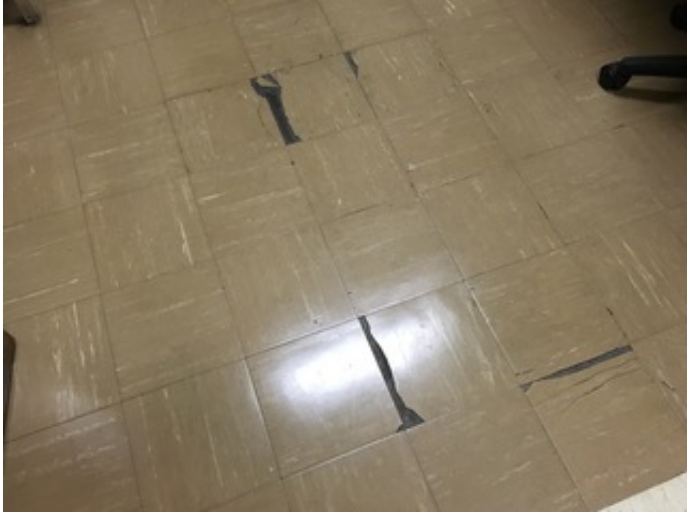
9" VAT

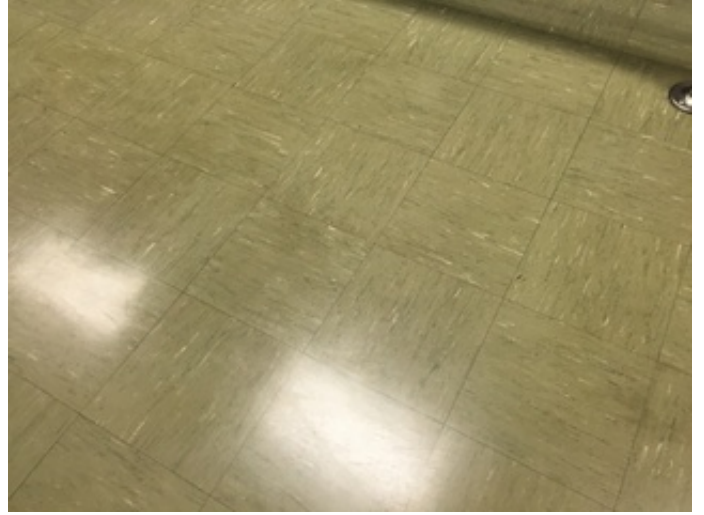
12" VAT
