**Building Information - Brunswick City (43661) - Willetts Middle**

**Building Pictures - Brunswick City(43661) - Willetts Middle(98426)**

**Building Component Information - Brunswick City (43661) - Willetts Middle (98426)**

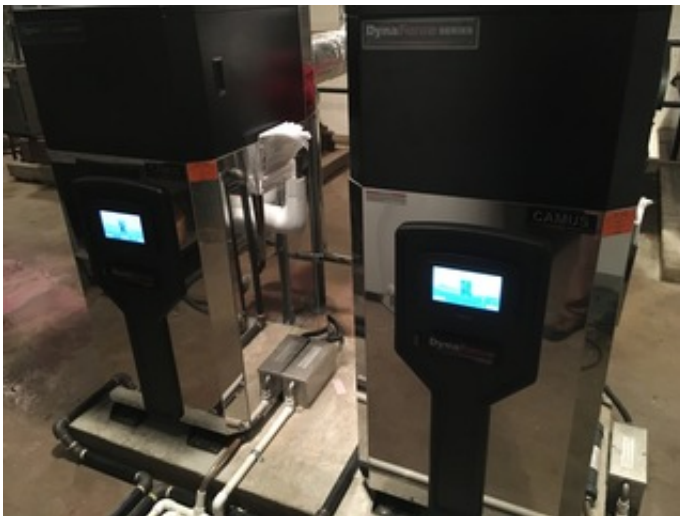
**Description:** The existing system for the Original Building and 1979 Addition is a system utilizing multiple air handling units with VAV terminal boxes and exterior condensing units with hot water heating coils installed in 1976, which are in fair condition. The heating system in the overall facility is a 2-pipe system, with a capacity for simultaneous heating and cooling operation, which is compliant with the OSDM requirements for basic system type. The (2) gas-fired heating water boilers, manufactured by Camus Model DRNH-0800 were installed in 2014 and are in good condition. Heating water is distributed to terminal units consisting of air handling units and VAV boxes. The terminal equipment was installed in 1976/1979 and is in fair condition. The system does comply with the 15 CFM per person fresh air requirements of the Ohio Building Code (OBC) mechanical code and Ohio School Design Manual (OSDM). The pneumatic / direct-digital-control (DDC) type system temperature controls were installed in 1976 with recent DDC upgrades and are in good condition. The system does feature individual temperature controls in all spaces required by the OSDM. The existing system for the overall facility is ducted. The overall heating system is evaluated as being in safe and efficient working order, though long-term life expectancy of the existing system is not anticipated for the Original Building and 1979 Addition. The structure is equipped with central air conditioning. The site does not contain underground fuel tanks.

**Rating:** 3 Needs Replacement

Heating water boiler

**Recommendations:** Overall Facility: Due to the age of the system, provide new overall heating, ventilating, and air conditioning system with new ductwork to achieve compliance with OBC and OSDM standards.

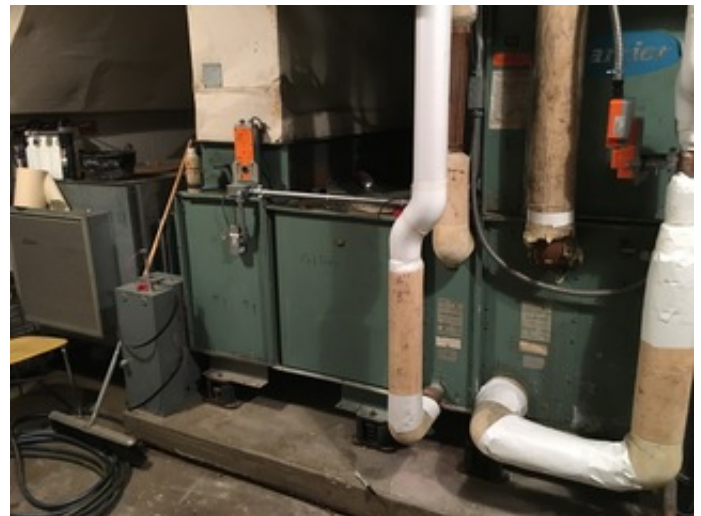
Air handling unit

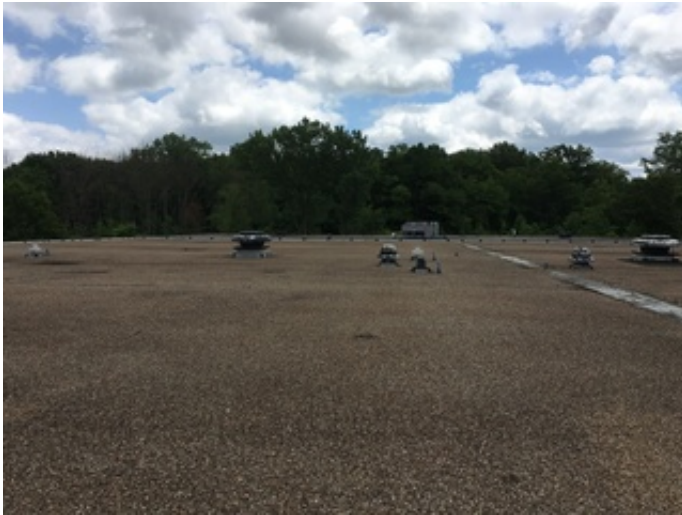
**Description:** The roof over the overall building is a coal-tar built-up roof system installed in 1976 and 1979. The system is in poor condition. District Administration reported the BUR system has been problematic and is ponding water in a few areas. Access to the roof was gained by direct walkout access. Fall safety protection cages are not required, and are not provided. Termination and counter flashings are corroded. Edge trim and cap flashing at the overall facility are in fair condition. Roof storm drainage is addressed through a system of roof drains. The overall building is not equipped with overflow protection.

**Rating:** 3 Needs Replacement

BUR System

**Recommendations:** Provide for replacement of the BUR system due to age of installation and condition at the overall building and provide for replacement of edge trim/coping. Provide an overflow drainage system in conjunction with roof replacement.

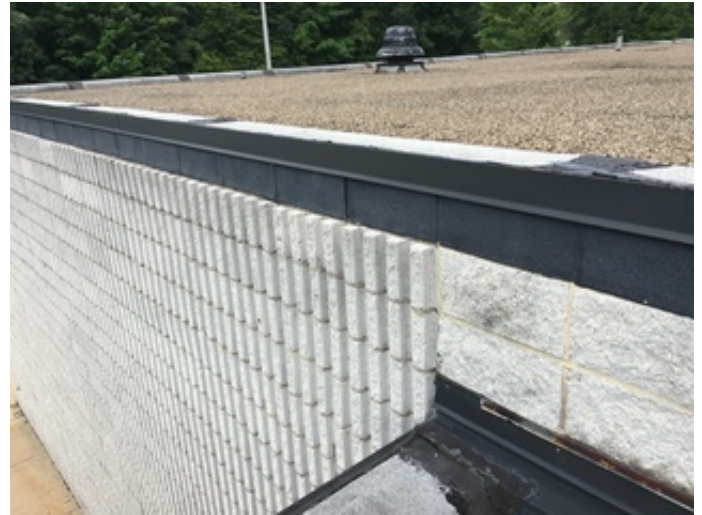
Edge trim and counterflashing

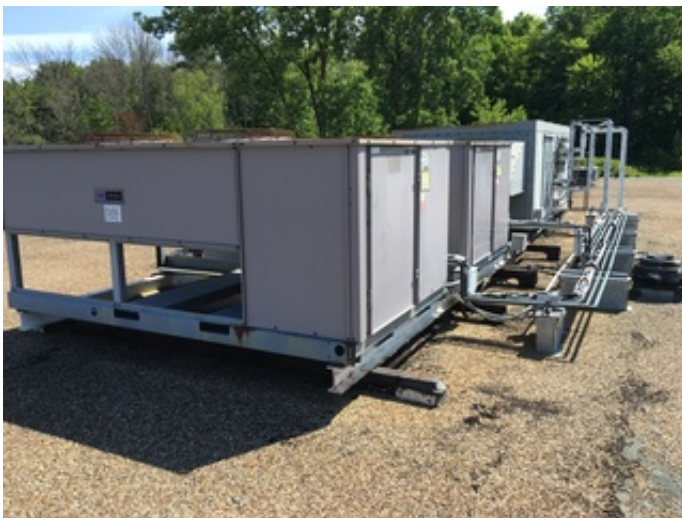
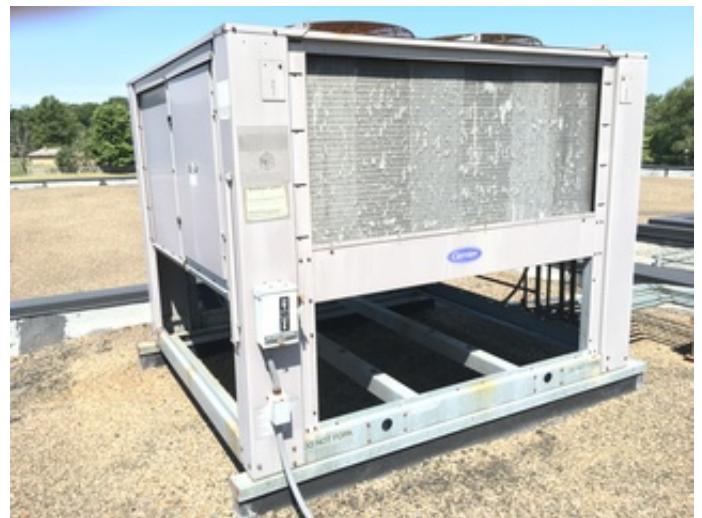
**Description:** The Original Building and 1979 Addition is equipped with a self-contained unit ventilation air conditioning system, installed in 1976 which is in fair condition. The ventilation system in the Original Building and 1979 Addition consists of air handling units, which are in fair condition, providing fresh air to Classrooms. Relief air venting is provided by ceiling plenums. The ventilation system does meet the Ohio Building Code (OBC) 15 CFM per occupant fresh air requirement. The overall system is partially compliant with OBC and Ohio School Design Manual (OSDM) requirements. Exhaust systems for Restrooms / Kitchen / Gymnasium / Storage Rooms / Custodial Closets are adequately placed, and in good condition.

Air cooled condensing unit

**Recommendations:** Original Building and 1979 Addition: Provide an air conditioning system with new ductwork to meet with OBC and OSDM requirements. Pricing included in Item A.

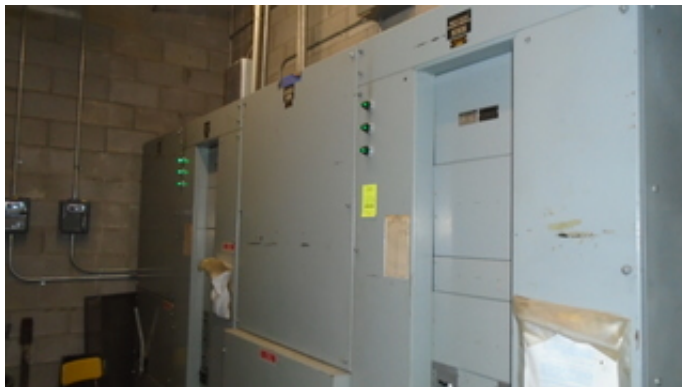
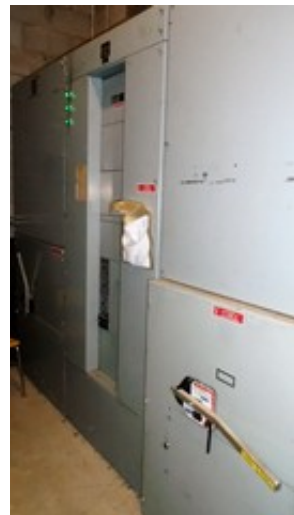
**Description:** The electrical system provided to the overall facility is a 480/277-volt, 800-amp, 3-phase, 4-wire system installed in 1976, and is in fair condition. Power is provided to the school by single utility-owned, pad-mounted transformer located behind the school, which is in good condition. The panel system for the Original Building and 1979 Addition, installed in 1976, is in fair condition, and cannot be expanded to add additional capacity. Original Building and 1979 Addition: The Classrooms are equipped with adequate electrical outlets, which are both surface and flush. 2010 Addition: The Classrooms are equipped with adequate electrical outlets. The typical Classroom contains (9) general purpose outlets The Corridors are equipped with adequate electrical outlets for servicing. Adequate GFI protected exterior outlets are provided around the perimeter of the building. The facility is not equipped with an emergency generator. Adequate lightning protection safeguards are not provided. The Original Building and 1979 Addition system does not meet Ohio School Design Manual (OSDM) requirements in supporting the current needs of the school, and will be inadequate to meet the facility's future needs. 06-25-21 Update: Lightning Protection scope and budget is included in complete replacement; therefore, individual line item for lightning protection is not required.

**Rating:** 3 Needs Replacement

Electrical switchgear

**Recommendations:** Original Construction (1976/1979): The entire electrical system requires replacement to meet OSDM guidelines due to condition and age. Provide lightning protection at the overall facility. 06-25-21 Update: Lightning Protection budget included in complete system replacement; therefore, the individual line item for lightning protection has been removed.

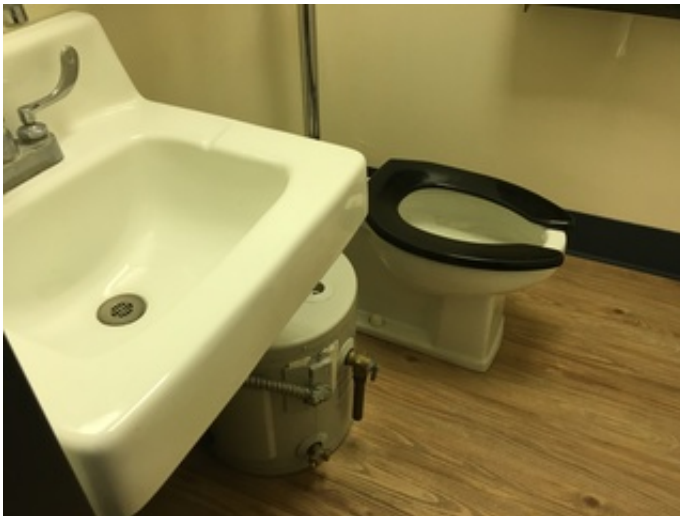
**Description:** The service entrance is equipped with a 3" reduced pressure backflow preventer in good condition. The domestic water supply piping in the overall facility is copper, was installed in 1976 and 1979 and is in good condition. The waste piping in the overall facility is cast iron or PVC, was installed in 1976 and 1979 and is in good condition. The overall building is equipped with (2) A.O. Smith Model DRE 80 100 electric water heaters in good condition. The Kitchen is provided the required 140-degree hot water supply. The school facility contains eight group/locker room restrooms (4 girls, 4 boys), 1 clinic toilet, 1 kitchen toilet, 1 classroom toilet, and 3 staff/public restrooms. Fixtures are a combination wall and floor mounted toilets, wall mounted urinals and wall mounted lavatories. Fixtures have been updated at select locations at the overall building, but the majority of fixtures are original to date of construction. Portions of the toilet facilities have been renovated to provide accessible accommodations but do not fully conform to the provision of the ADA or ANSI guidelines. The locations of flush valves at accessible water closets obstruct grab bar installations in several areas. Vertical grab bars at water closets are not installed at required locations. Faucet assemblies are typically manual. Fixtures are generally in fair to good condition. The school meets the OBC requirement for fixture count. ADA/ANSI requirements are not met for fixtures and drinking fountains (refer to item O). A portion of the toilet facilities and drinking fountains throughout the building are not accessible and do not conform to the provisions of the ADA/ANSI guidelines.

**Rating:** 3 Needs Replacement

Typical fixtures

**Recommendations:** Provide new fixtures to replace existing wall and floor mounted fixtures because of age and water efficiency at the overall building. Replace water and sanitary waste piping throughout the facility due to age. Refer to Item O for accessible provisions.

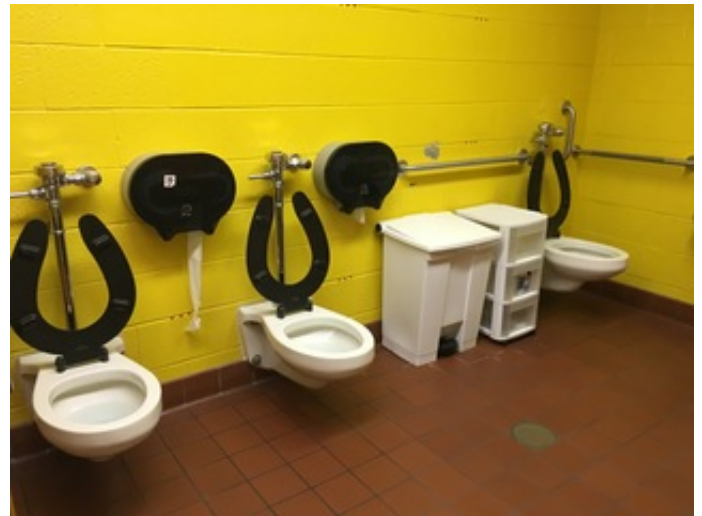
Water closets

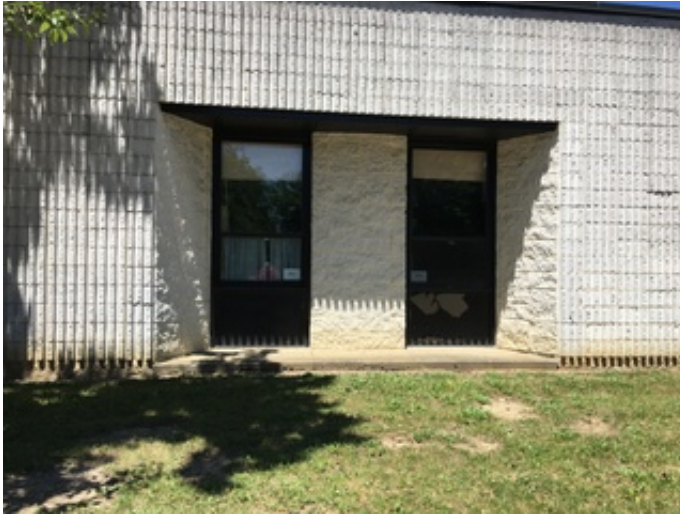
**Description:** The overall building is equipped with an operable aluminum window system with double pane insulated glazing units. The units are not equipped with integral blinds. The window system is in poor condition and includes infill panels that are reported to contain asbestos. Entrances are equipped with transom and side light assemblies which are equally in poor condition. The window and entry assemblies exceed 20+ years of age and have reached their useful life expectancy. This facility is not equipped with any curtain wall systems and does not feature any glass block windows.

**Rating:** 3 Needs Replacement

Typical window

**Recommendations:** Replace all windows assemblies at the overall building due to age and condition and provide a new insulated window system with integral blinds to meet the Ohio School Design Manual requirements. Replace sidelights of transoms at entry with a thermally efficient storefront system.

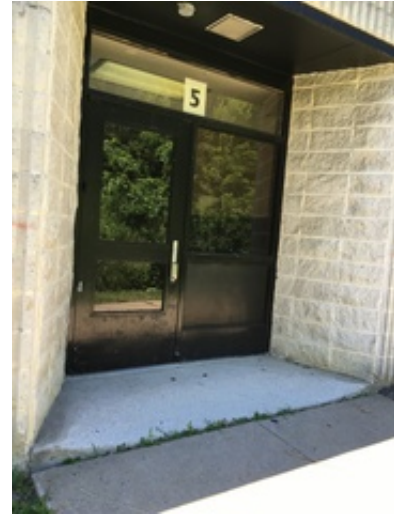
Typical entry

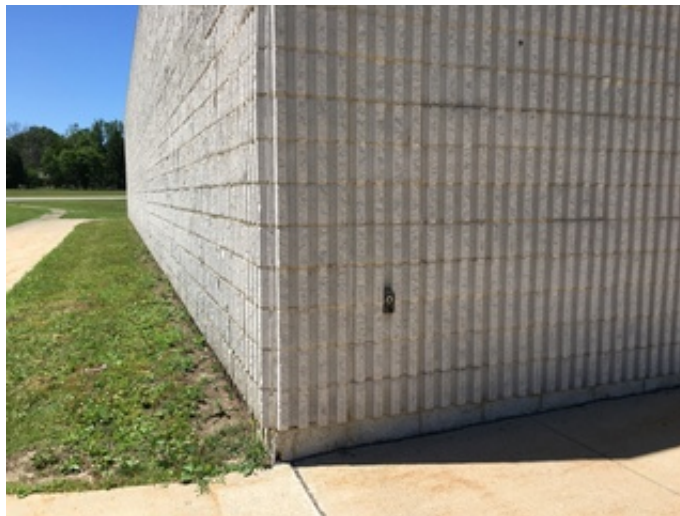
**Description:** The overall facility is equipped with concrete masonry unit foundation walls on concrete footings, which displayed no locations of significant differential settlement, cracking, or leaking, and are in satisfactory condition.

Building grade

**Recommendations:** The existing conditions at the overall building require no renovations or repair at the current time.

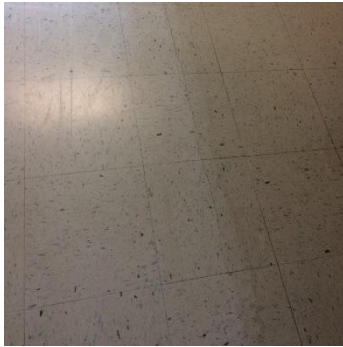
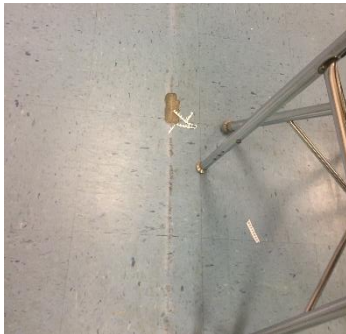
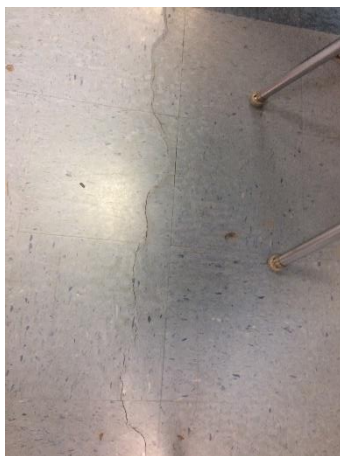
The classroom addition in the 1979 has significant wall cracks and movement of bearing wall and floor slab due to settlement. The interior masonry wall may require demolition, as well as the concrete riser slab, slab on grade, and affected interior doors. New fill & compaction will be required as well as new floor slabs including riser, CMU wall and doors. Due to the quick deterioration of the structure an assessment by a structural engineer is recommended for the addition.

Classroom Floor Crack

1979 Classroom Addition: Repair Allowance: Lump Sum = \$2,000,000

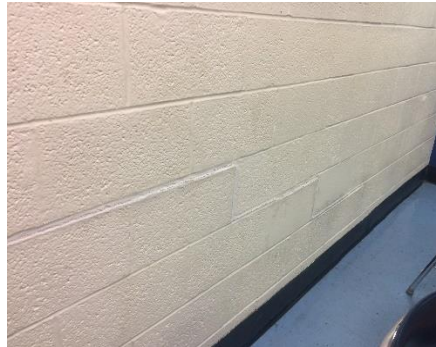
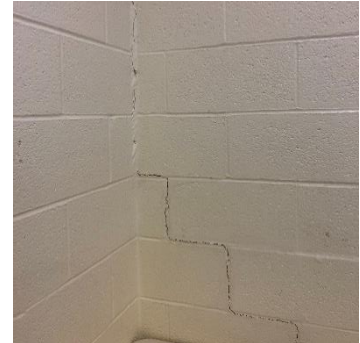
Classroom Stepping Crack

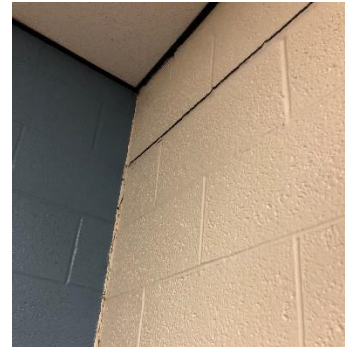
Classroom CMU Crack

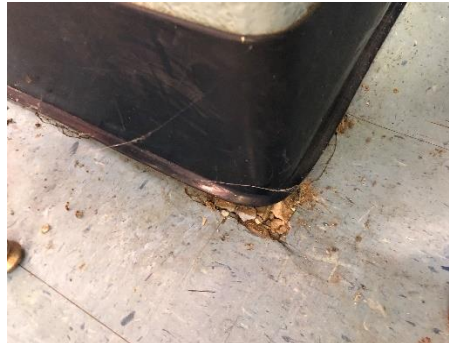
Classroom Corner Settling

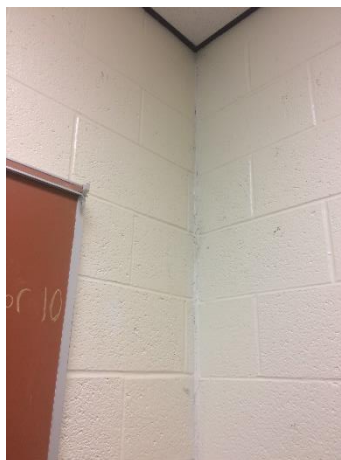
Classroom Vertical wall

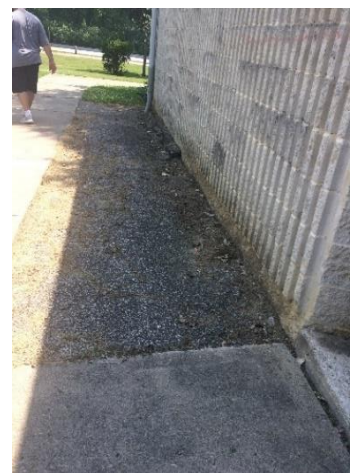
Exterior Building Settlement

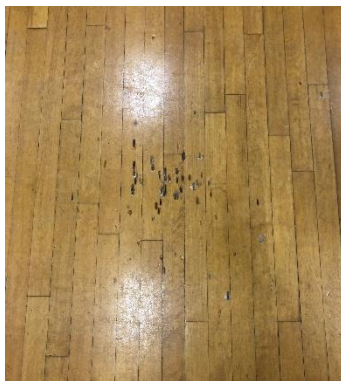
The 1976 Original Building Gymnasium floor needs to be replacement, as well as the old bleachers which are in need of updating and repair. The original partition wall is in need of replacement. There are four basketball backboards and all components that are in need of replacement. Additional wall padding is required in required areas. The cafeteria area does not have acoustics and it will need to be added along with replacement of the music room acoustics. Demolition of the fixed riser system in the music room will need to take place.

Damaged Wood Flooring in Gym

1976 Original Building: Gymnasium: New Operable Partition Wall =	\$70,000
1976 Original Building: Gymnasium: Wood Flooring: 7,588 sf x \$12.85/sf =	\$97,505.80
1976 Original Building: Gymnasium: New bleacher seats: 600 x \$110.00/seat =	\$66,000
1976 Original Building: Gymnasium: Basketball Backboards: = 4 units x 6,500/unit =	\$26,000
1976 Original Building: Gymnasium: Additional Wall padding: Lump Sum =	\$15,000
1976 Original Building: Additional Acoustics in Gymnasium: Lump Sum =	\$30,000
1976 Original Building: Additional Acoustics in Cafeteria: Lump Sum =	\$15,000
1976 Original Building: New Acoustics in Music Room: Lump Sum =	\$20,000
1976 Original Building: Demolition/New Modular Riser System in Music Room: Lump Sum =	\$9,000

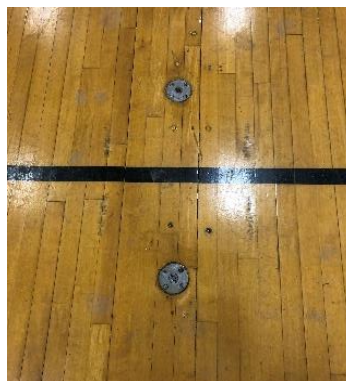
Basketball Hoop

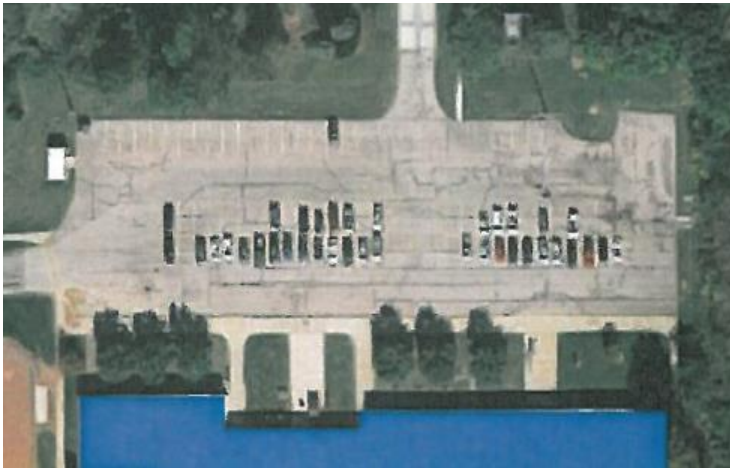
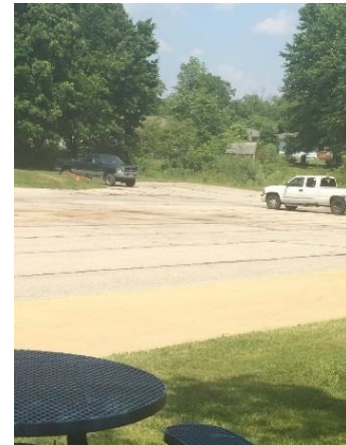
Replacement of heavy-duty asphalt is recommended throughout all area due to the current deterioration of the existing surface and subgrade. There is a requirement for additional widening at the Hadcock Road school entrance due to the bus access. Additional accessible parking spaces are required. City Engineers likely to require storm water retention due to ongoing issues downstream from southern drainage ditch. Additional Catch basing in parking lot recommended to address site drainage issues.

Back Parking Lot

Back Parking Lot - Full Replacement: Heavy Duty 5,750 sy x 30.60/sy =	\$175,950
Entrance Drive Widening from Excellence to Warren Drive: 233 yd x 5' = 1,165 x \$48/sqyd =	\$55,920
Additional Accessible Parking Spaces: Adding 2 spaces @ \$1,000 EA =	\$2,000
Storm Water Retention: Allowance =	\$150,000
Provide for Additional Catch Basins in Parking Lot: \$10,000/unit x 4 =	\$40,000

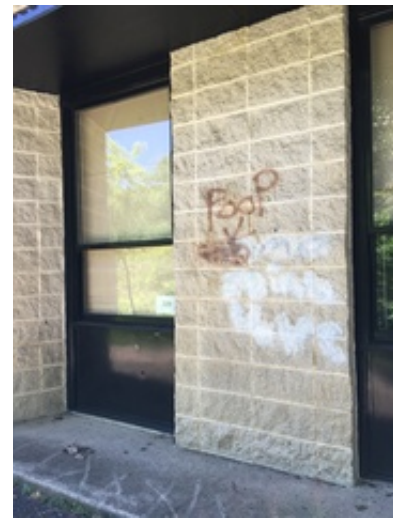
**Description:** The Original Building and 1979 Addition have a scored split-face CMU masonry bearing wall system, which displays limited areas of deterioration and is generally in good condition. Wall surfaces are soiled and have graffiti in several locations. The overall building is not equipped with control joints but there are no substantial areas of cracking. The exterior masonry has not been cleaned and sealed in recent years and shows evidence of mortar deterioration in a few locations.

**Rating:** 2 Needs Repair

Wall surface damage

**Recommendations:** Provide tuckpointing in all areas of mortar deterioration. Provide masonry cleaning and sealing at the overall building.

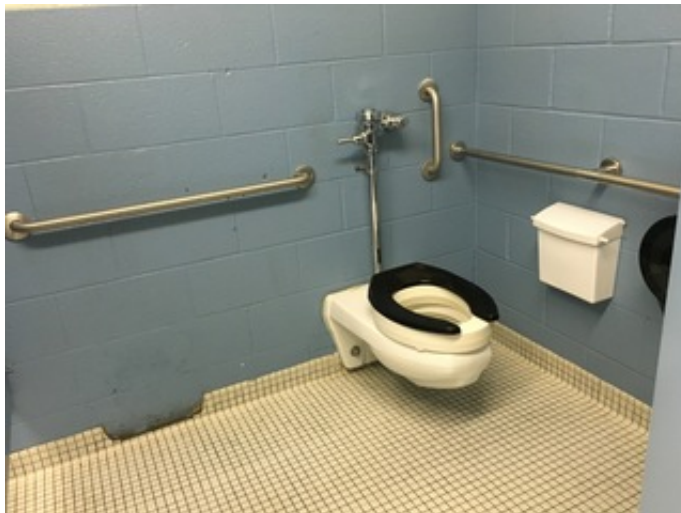
Obstructed grab bar installation

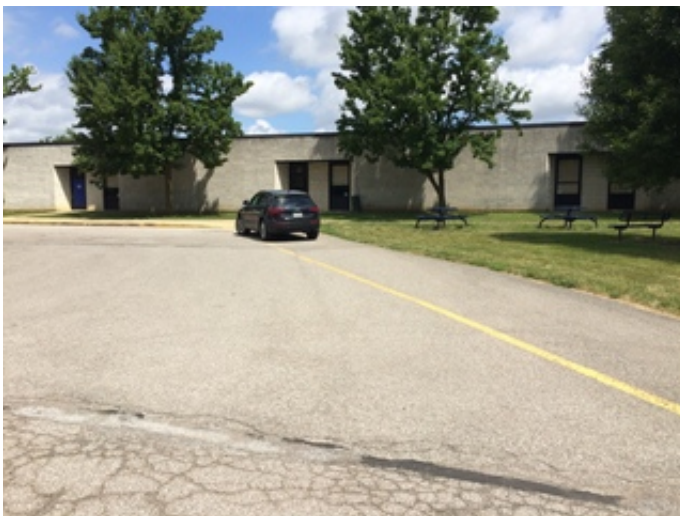
Unprotected pedestrian way along front drive

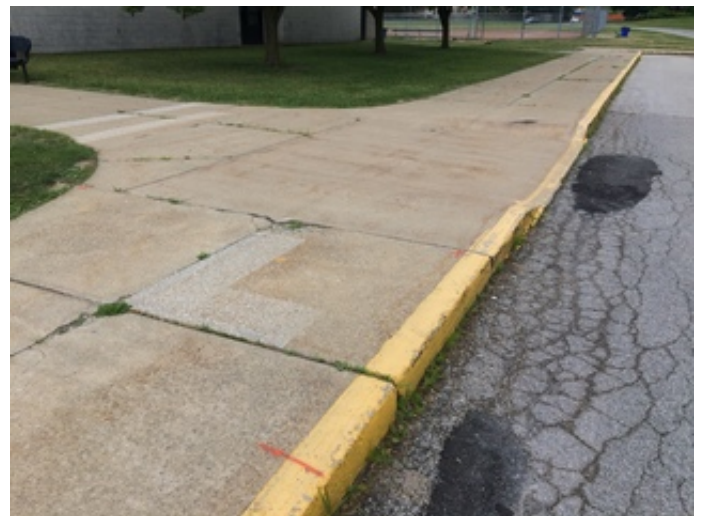
Damaged pavement/walk & non-compliant ramp
