**Building Information - Brunswick City (43661) - Willetts Middle**

**Building Pictures - Brunswick City(43661) - Willetts Middle(98426)**

**Building Component Information - Brunswick City (43661) - Willetts Middle (98426)**

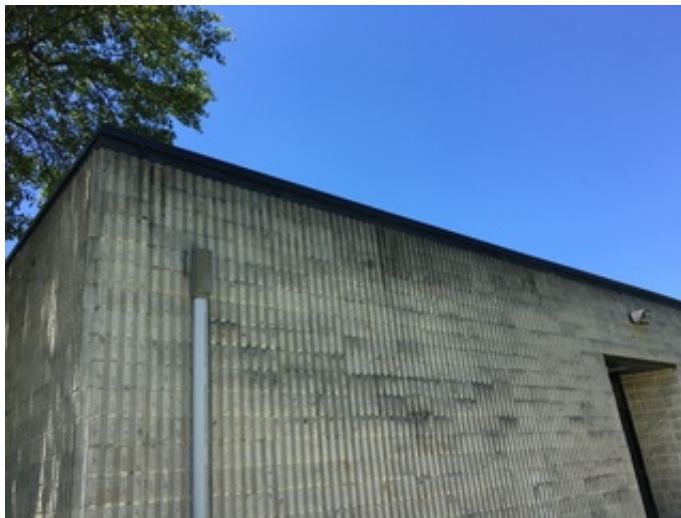
Typical wall

**Recommendations:** Provide tuckpointing in all areas of mortar deterioration. Provide masonry cleaning and sealing at the overall building.

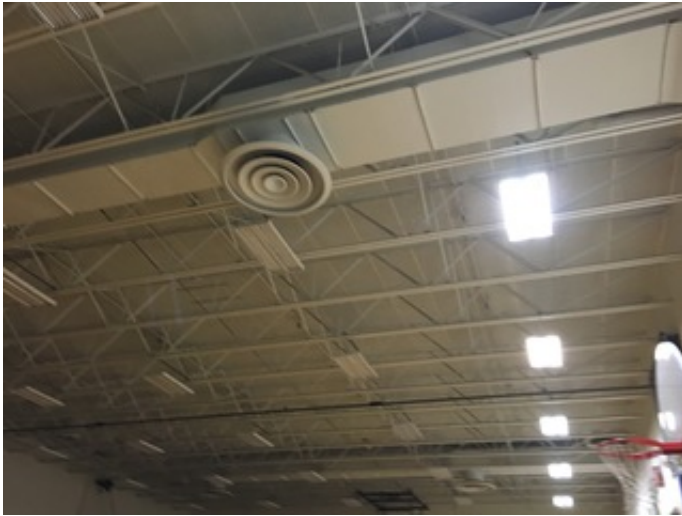
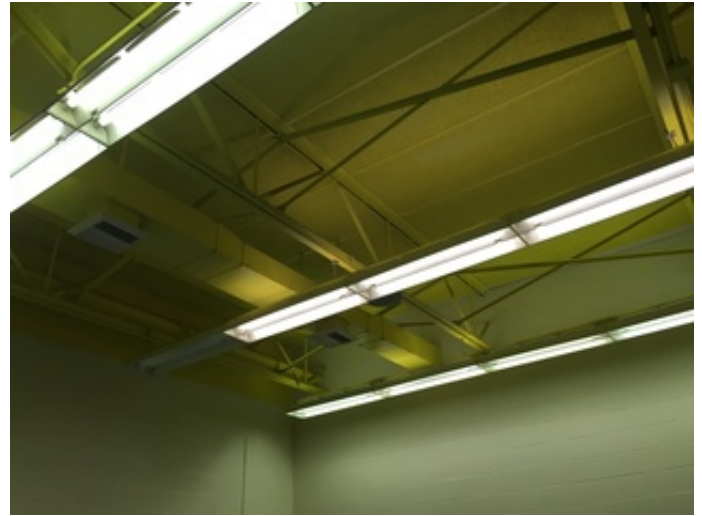
Joist framing

**Recommendations:** Existing conditions require no renovation or replacement at the present time.

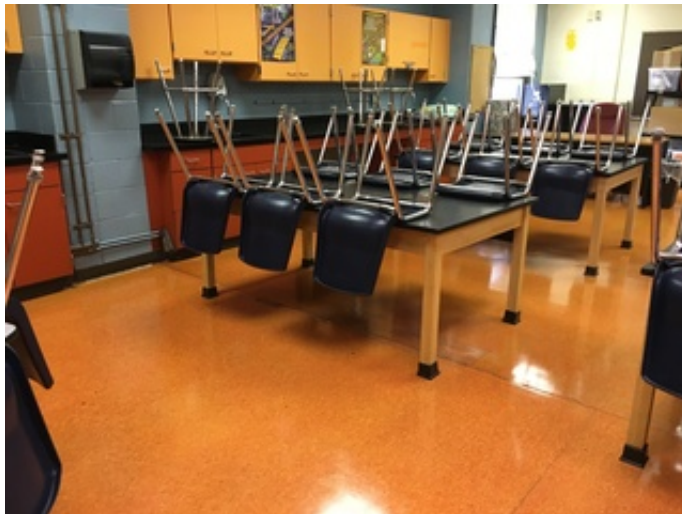
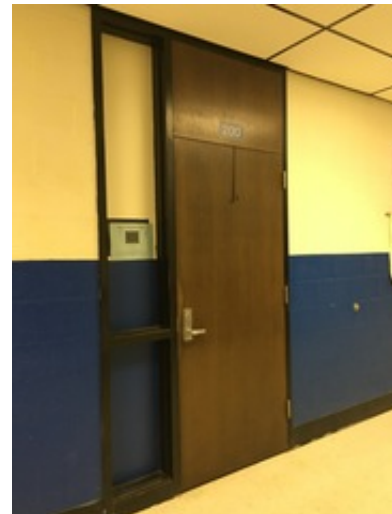
Typical classroom

Typical classroom door

**Recommendations:** Updated finishes are in good condition, but replacement of the remaining dated finishes exceeds 2/3 the cost of full replacement. Provide complete replacement of kitchen equipment at the Original Building due to age and condition of existing equipment. Provide complete replacement of finishes, doors, and casework throughout the overall building to conform to OSDM guidelines, and due to age and condition of existing finishes. Refer to Plate O for door and accessibility improvements.

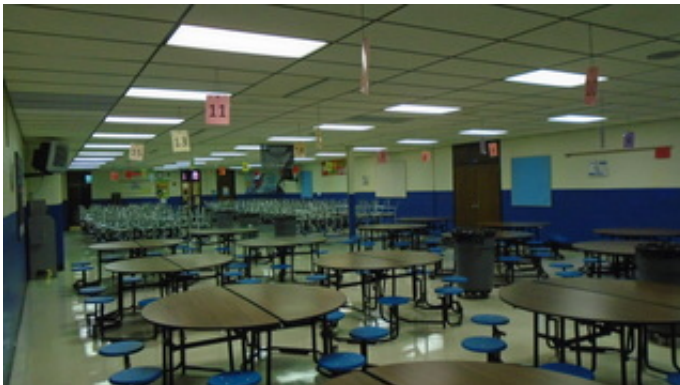
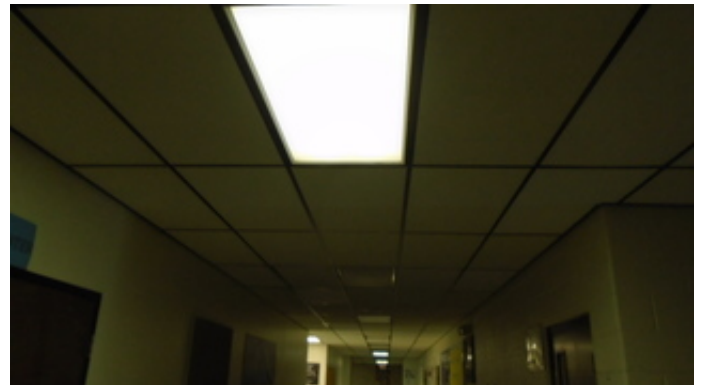
Student Dining lights

Corridor lights

Provide complete replacement of lighting system due to HVAC System replacement and addition of suppression system.

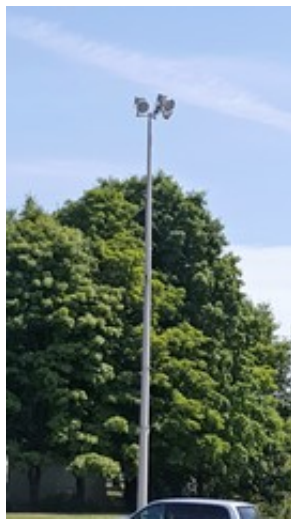
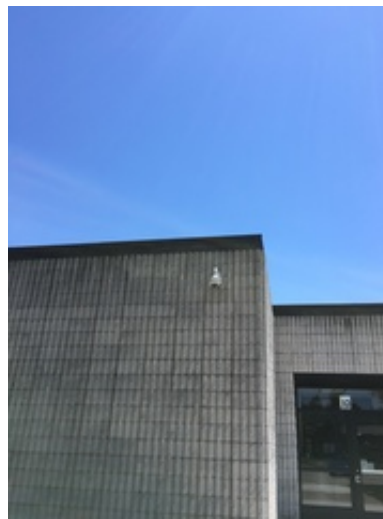
Pole light

Camera

**Recommendations:** Provide complete replacement of the security system to meet the Ohio School Design Manual guidelines and due to installation of systems outlined at Items K and U.

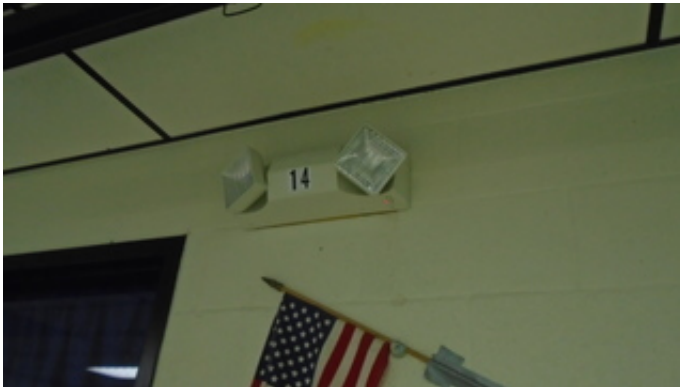
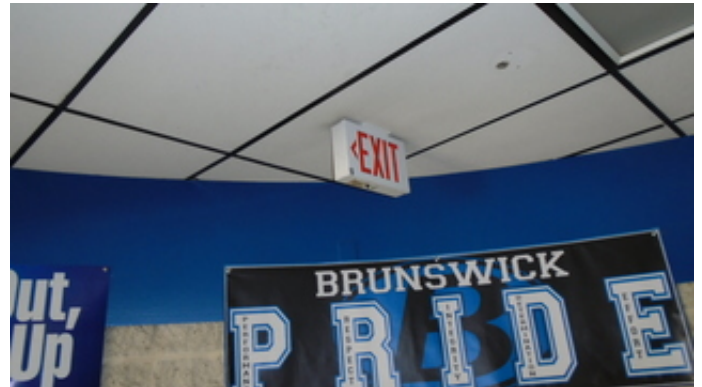
Emergency Light

Exit Light

**Recommendations:** Replace all emergency / egress lighting and connect to the new emergency generator, to meet Ohio School Design Manual guidelines.

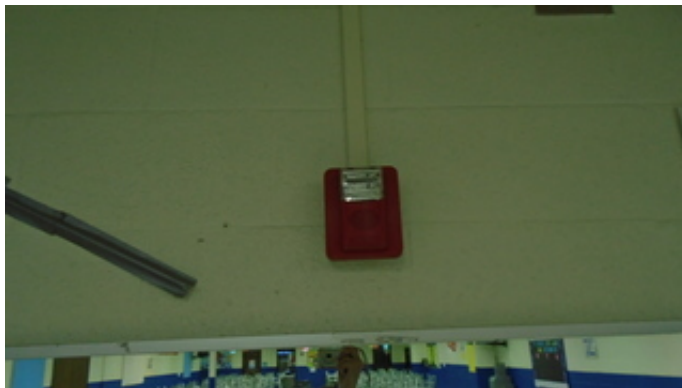
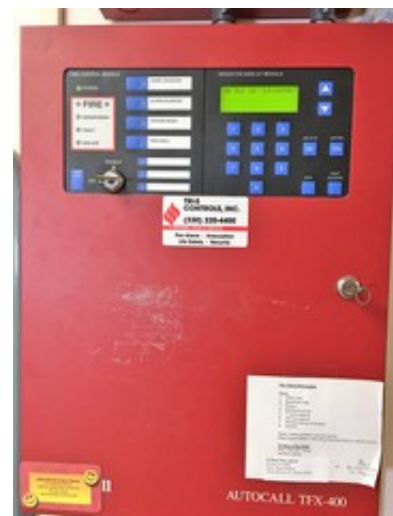
Typical audio/visual strobe

Fire Alarm Panel

**Recommendations:** Provide new fire alarm system due to other system renovations and to meet OBC, NFPA, and Ohio School Design Manual guidelines.

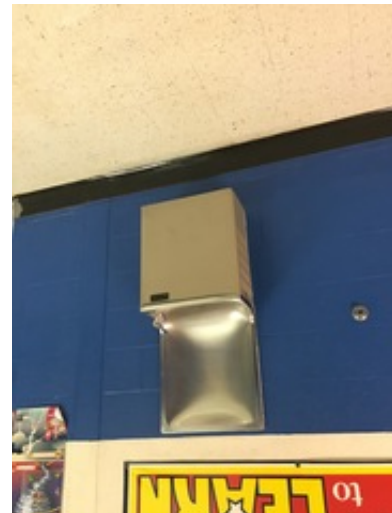
Drinking fountain

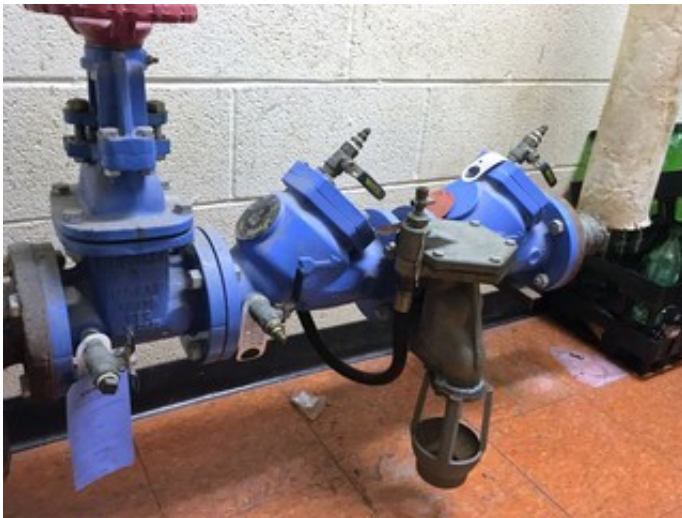
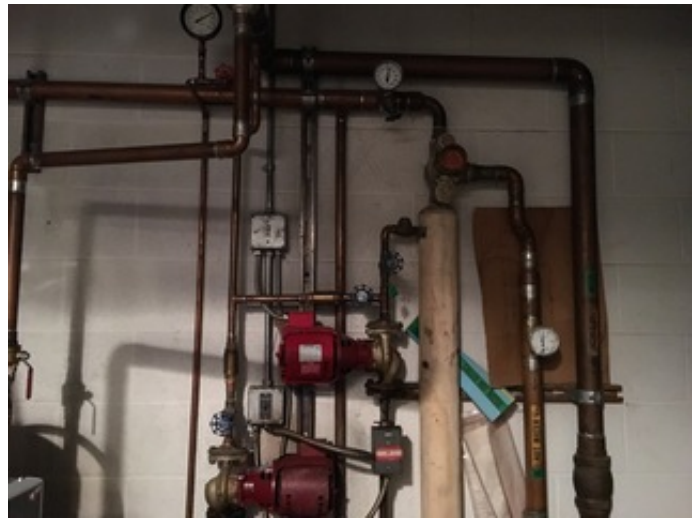
Main water BFP

Main domestic hot water return

**Recommendations:** Provide a new city water supply line of adequate capacity to support the existing needs of the facility, as well as a future automated fire suppression system. Funding provided in Item U.

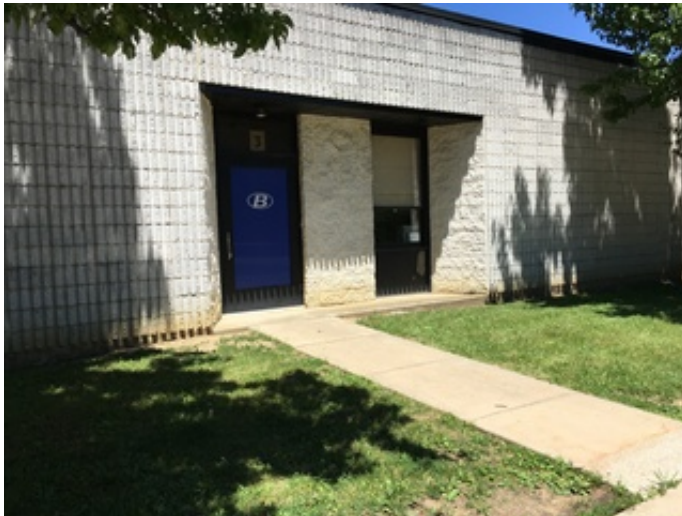
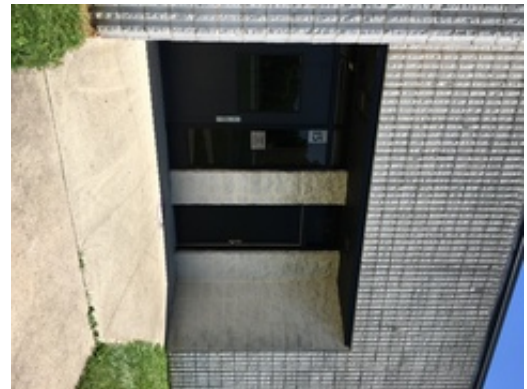
Typical door

**Recommendations:** Replace all exterior, deteriorated and damaged doors at the overall building to comply with Ohio Building Code, ADA, and Ohio School Design Manual guidelines.

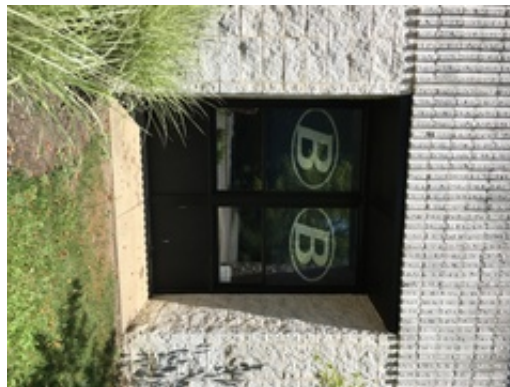
Window panels

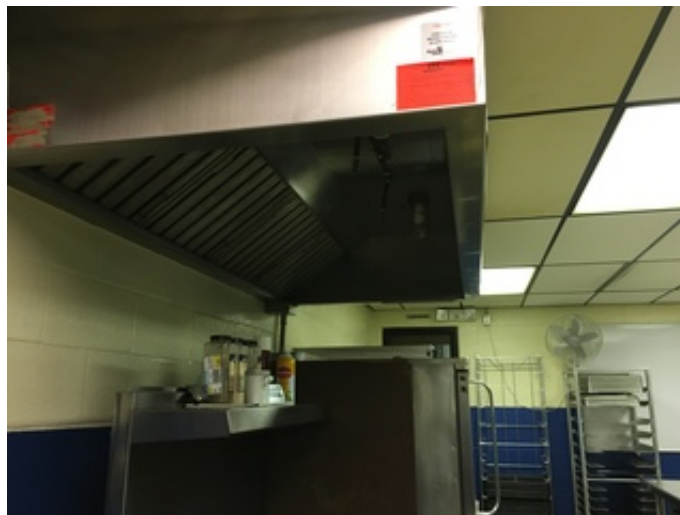
Kitchen hood

**Recommendations:** Provide new automated fire suppression system to meet OSDM guidelines. Provide increased water service of a capacity sufficient to support the fire suppression system, funding included in fire suppression funding. Provide an emergency generator, funding provided at plate D. 06-25-21 Update: Provide for a dedicated water line and backflow preventer to service Sprinkler System.

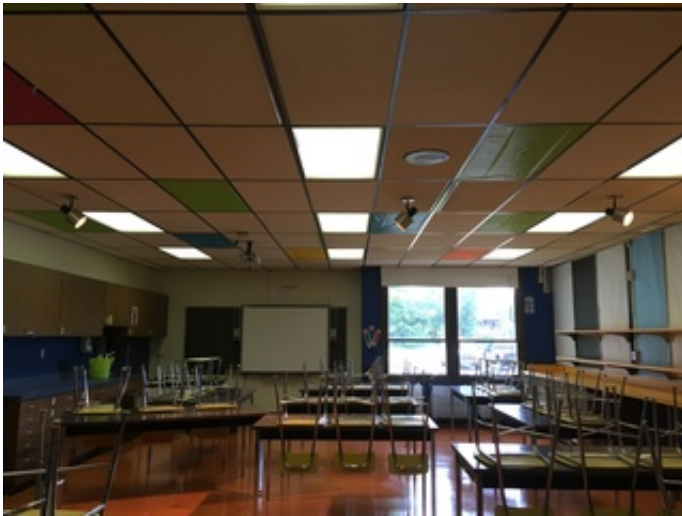
Typical classroom

**Recommendations:** Provide for replacement of outdated or inadequate furniture. 6-25-21 Update: Change budget from \$4.50/sf to \$6.50/sf.

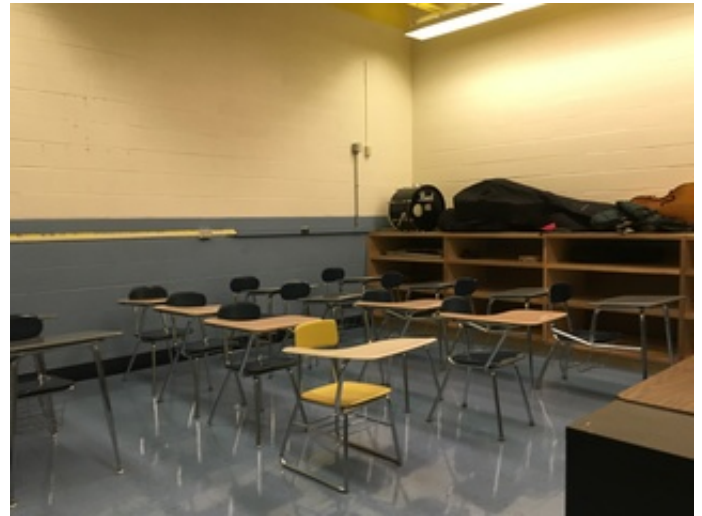
**Description:** The typical Classroom furniture at the overall building is a combination of newer and dated furnishings, and in generally fair to good condition. The facility's furniture and loose equipment were evaluated in Item 6.17 in the CEFPI section of this report, and on a scale of 1 to 10 the overall facility received a rating of 6 due to observed conditions. 06-25-21 Update: Based on age and condition of existing and increased costs for classroom furniture, the loose furnishings budget should be increased from \$4.50/sf to \$6.50/sf.

**Rating:** 3 Needs Replacement

Typical classroom

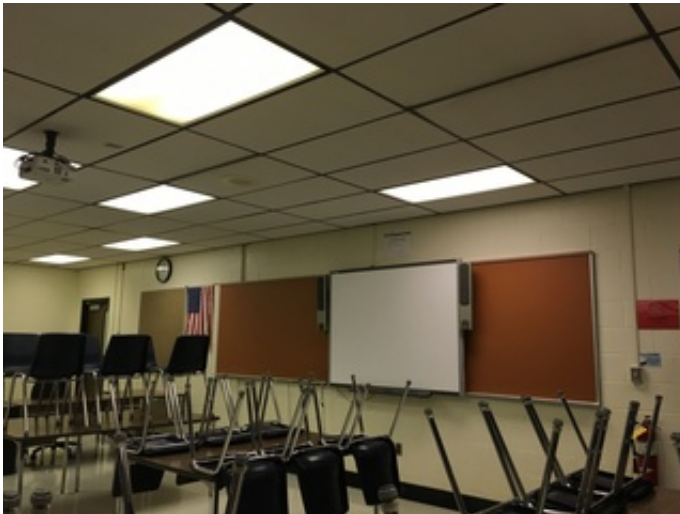
**Rating:** 3 Needs Replacement

Interactive display board

**Recommendations:** Provide complete replacement throughout the complex of technology systems to meet Ohio School Design Manual requirements, and to sustain the capacity to keep pace with technological development.

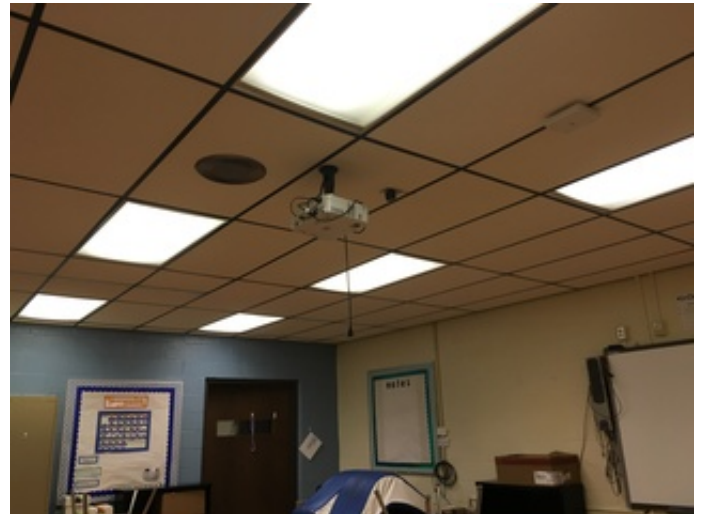
Projector
